Manhole Inspection Summary

Manhole # S49A__006MH

Insp Date: **10/2/08 9:33 AM**

Location Address: **2618 orleans st**

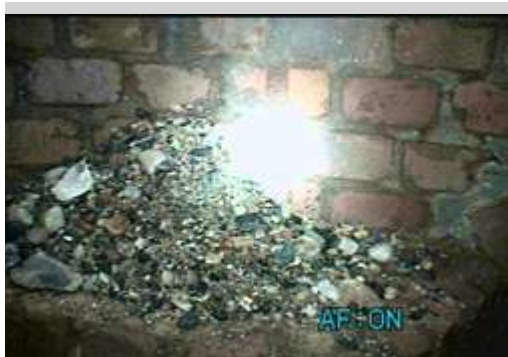
Defect 4

Condition: ☐ Sound ☐ Cracked ☐ Root Intrusion ☐ Deteriorated ☐ Leaks ☒ **Debris**

bench debris

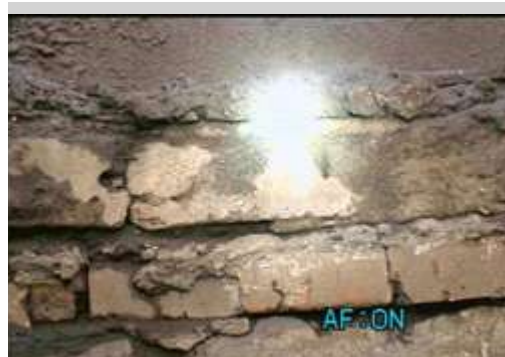
Defect 3

Chimney / Frame Adjustment ☒ Exists Material: **Brick and Concrete** ☐ Parged Height: **6.5** (in.)

Condition: ☐ Sound ☒ **Cracked** ☐ Root Intrusion ☒ **Loose Brick** ☒ **Deteriorated**

Infiltration: ☐ None ☒ **Joint** ☐ Cracks ☐ Mortar ☐ Roots ☐ Wall

chimney cracked, deteriorating and loose bricks with infiltration from joint

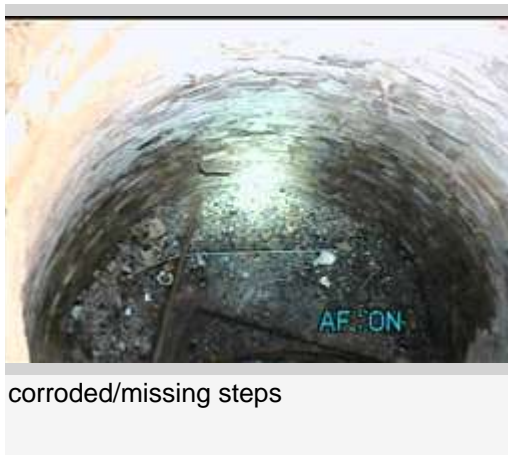
Defect 2

Steps Count: **3** Missing: **3** ☒ **Corroded**

corroded/missing steps

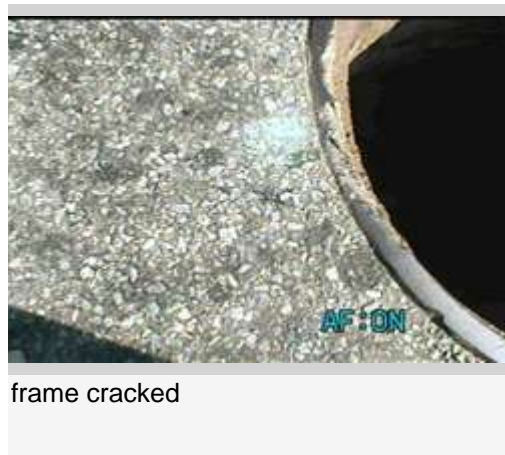
Defect 1

Frame Offset: **0** (in.) Condition: ☐ Sound ☒ **Cracked** ☐ Leaks

frame cracked
